AIAA 2000-3898

Development Status of the NASA MC-1 (Fastrac) Engine

Richard O. Ballard
NASA/MSFC

Tim Olive
NASA/MSFC

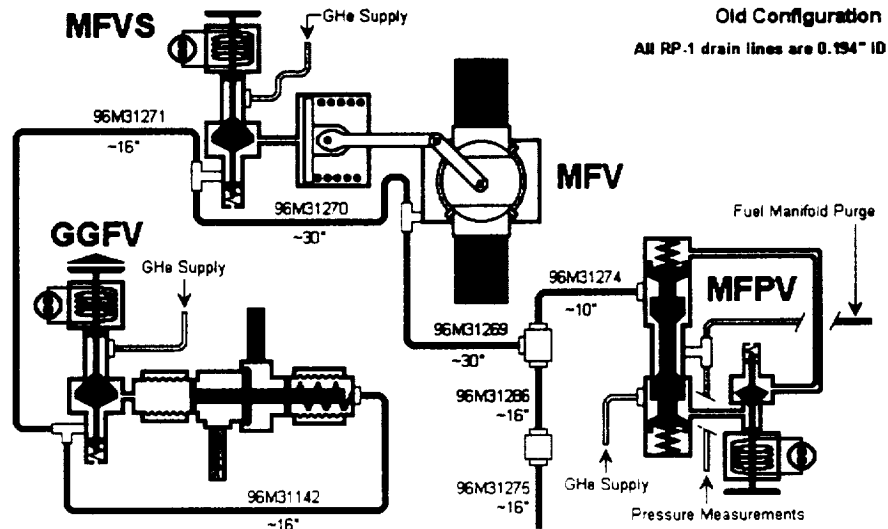
Figure 3: Old Vent Line Configuration

MFV Cycling Anomaly - During Firing Readiness Test (FRT) operations prior to test H0-4R, it was noted that the MFV cycled open without being commanded by the Propulsion System Controller (PSC). Testing was discontinued until it could be determined 1) if the MFV had actually cycled; 2) how it had cycled without being commanded; 3) how to prevent this event from reoccurring in the future. This caused significant concern due to the possibility that the root cause might allow other valves (esp. MOV) to cycle without being commanded. It was verified that the MFV did cycle without any command being issued by the controller. It was fortunate that the event occurred during the FRT, when no propellants were in the system. A fault tree was developed and investigated, pointing to the possibility that the MFV pneumatic piston may have been actuated by pressure from the MFPV vent port through the RP-1 drain lines and entering the pneumatic piston through the MFVS vent port. Because the drain lines are not

instrumented, verification of this failure mode was not possible. Part of the investigation involved a series of FRTs to cause the event to occur again, but it did not.

On the possibility of the existence of a "sneak circuit" between the vents of the MFPV and MFVS, the drain lines were separated to eliminate it. Lines 96M31270 and 96M31142 were separated from the 96M31274 MFPV drain line, shown below in Figures 3 and 4. To date, this anomaly has not recurred.
